**UNITED STATES ENVIRONMENTAL PROTECTION AGENCY
REGION IX**

Purpose: RCRA Compliance Evaluation Inspection

Facility: Semiray Special Processes

Date of Inspection: October 30, 2014
Time In/Time Out 11:40 AM – 2:00 PM

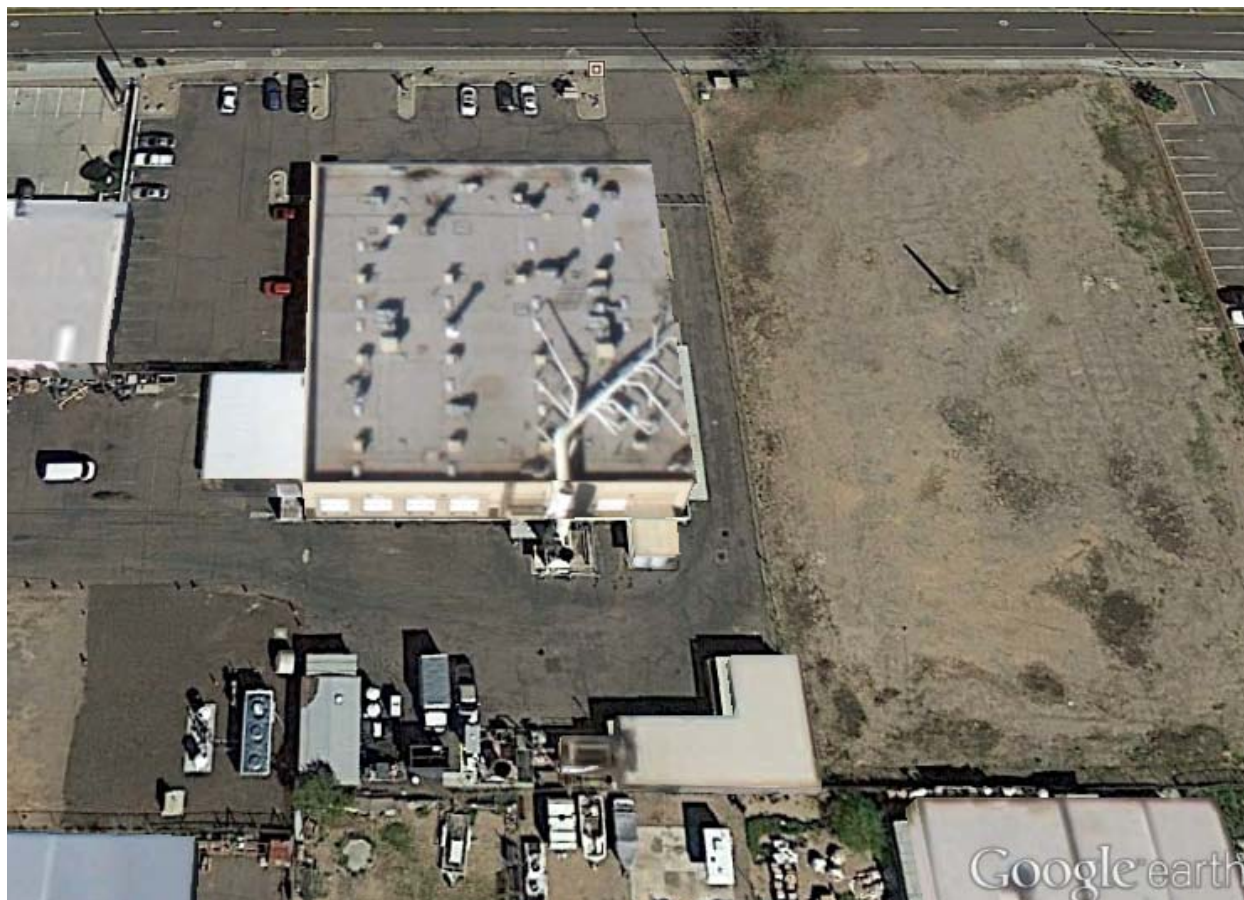
Below is an aerial photograph of the Semiray facility as taken from Google Earth Pro with an aerial dated March 2014. A site map of the facility has been included as Attachment 4.
